## Planning and Development Services

Report: PDS-22-2024

Heritage Property Designation – 5187 Sherkston Road

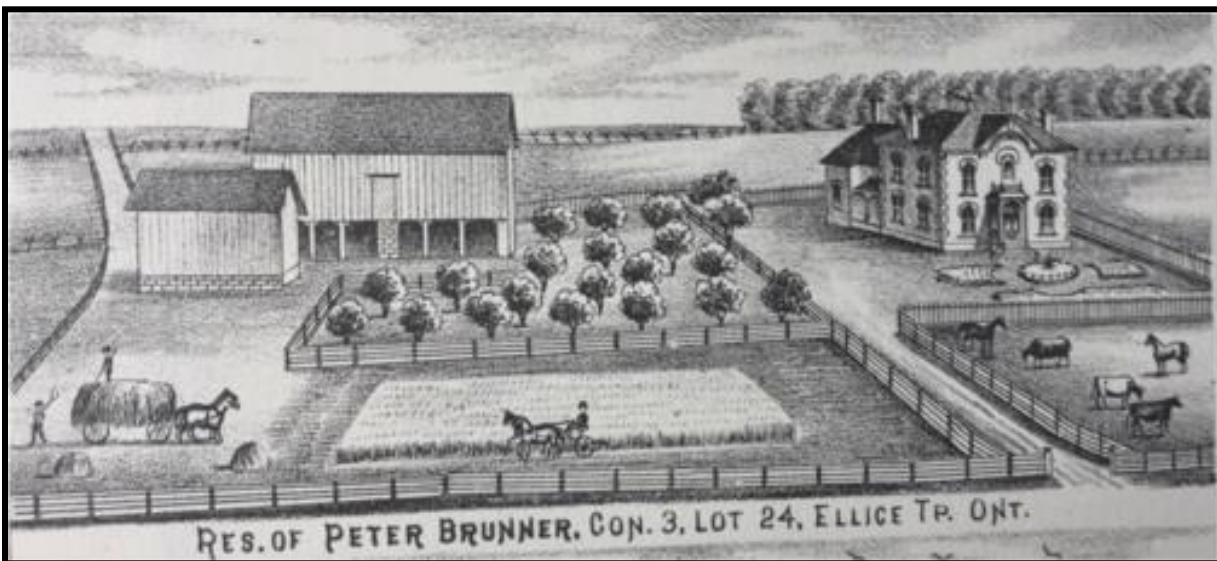
Figure 2: Historical Ontario Farmsteads (Illustration from Perth County Historical Atlas, 1879)

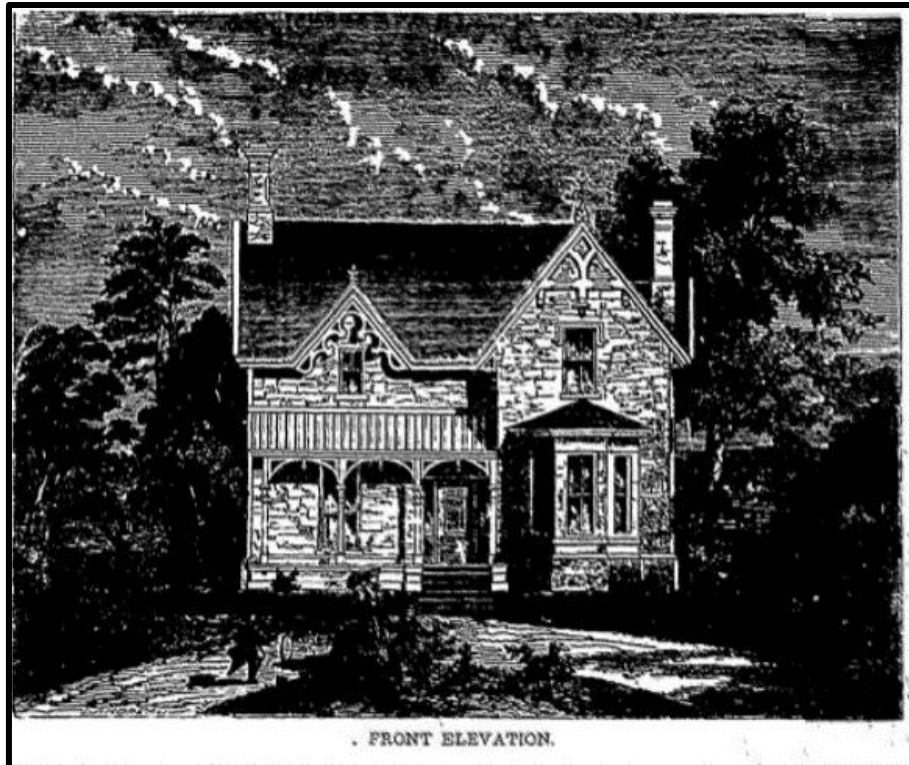
**Figure 3: “Suburban Villa or Farm House” The Canada Farmer (Brown 1864 vol 1/no. 9:132)**

In 1864 *Canada Farmer*, published three Gothic Revival prototypes: 1) “a small Gothic Cottage”, 2) “a suburban villa or farm house”, and 3) “A Cheap Farm House”. The prevalence of these styles in Ontario’s countryside is related to the pattern’s promotion in this free and easily accessible bi-weekly publication. The articles provide a sets of design guidelines for the construction of a house to accommodate large families; specifically, “A Suburban Villa or Farm House” in Vol. 1, No. 9. The article notes this prototype “... can be built with either brick, wood or stone, without interfering with the design...” (see Figure 3) (Brown 1864 vol. 1/no. 9:132).

The farmhouse at 5187 Sherkston Road is an example of the “Suburban Villa or Farm House” (Figure 3) that best align with the Gothic Revival architectural style principles outlined in this prototype. See Table 2 for a comparison of known characteristics of Gothic Revival style and features of the subject farmhouse at 5187 Sherkston Road.

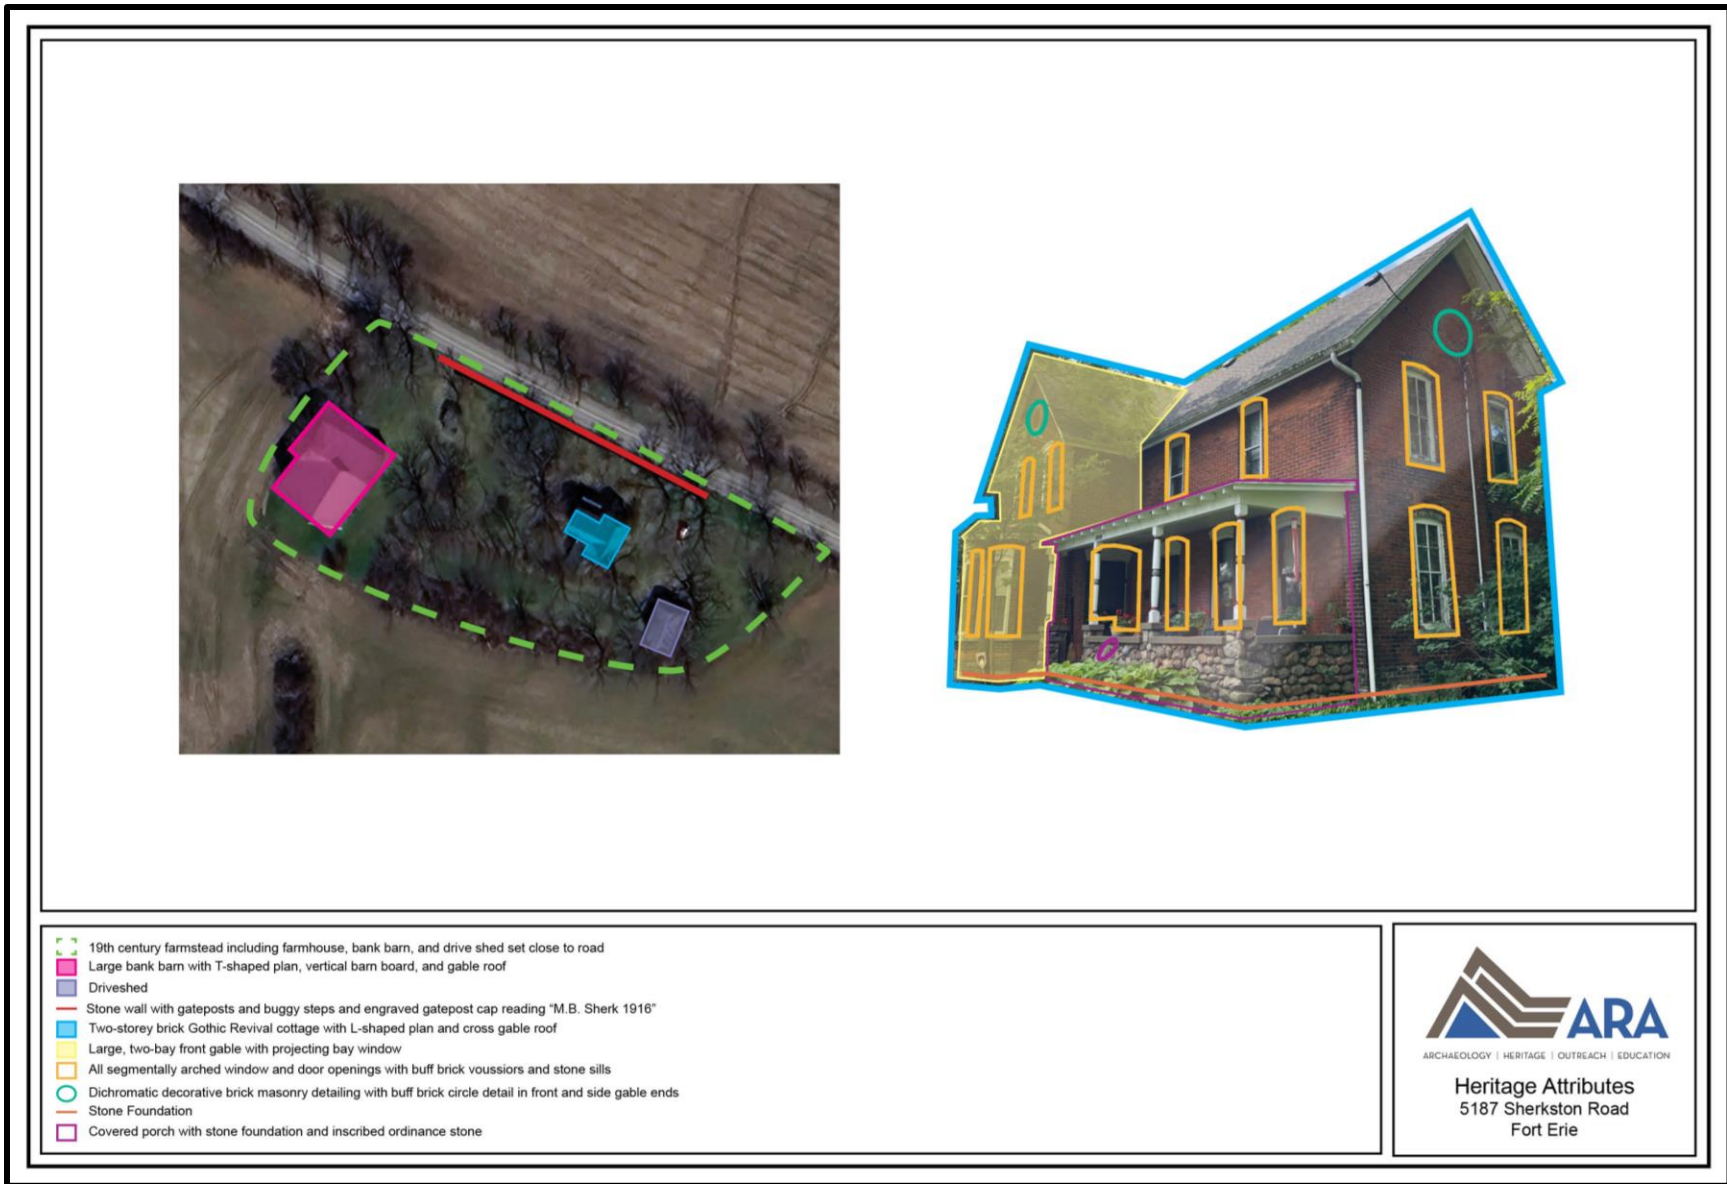
Map 3: Map of Heritage Attributes of 5187 Sherkston Road

The following figures display the heritage attributes as outlined above in Section 7.0.

- Stone wall with gateposts and buggy step
- Engraved gatepost cap which reads “M.B. Sherk 1916”
- Two storey brick Gothic Revival farmhouse:
  - L-shaped plan;
  - Cross gable roof;
  - Large two-bay front gable with projecting bay window
  - All segmentally arched window and door openings with buff brick voussoirs and stone sills
  - Dichromatic decorative brick masonry detailing with Buff brick circle detail in front and side gable ends;
  - Stone foundation
  - Covered porch with stone foundation
  - Inscribed ordinance stone
- Large bank barn:
  - T-shaped plan;
  - Vertical barn board
  - Gable roof

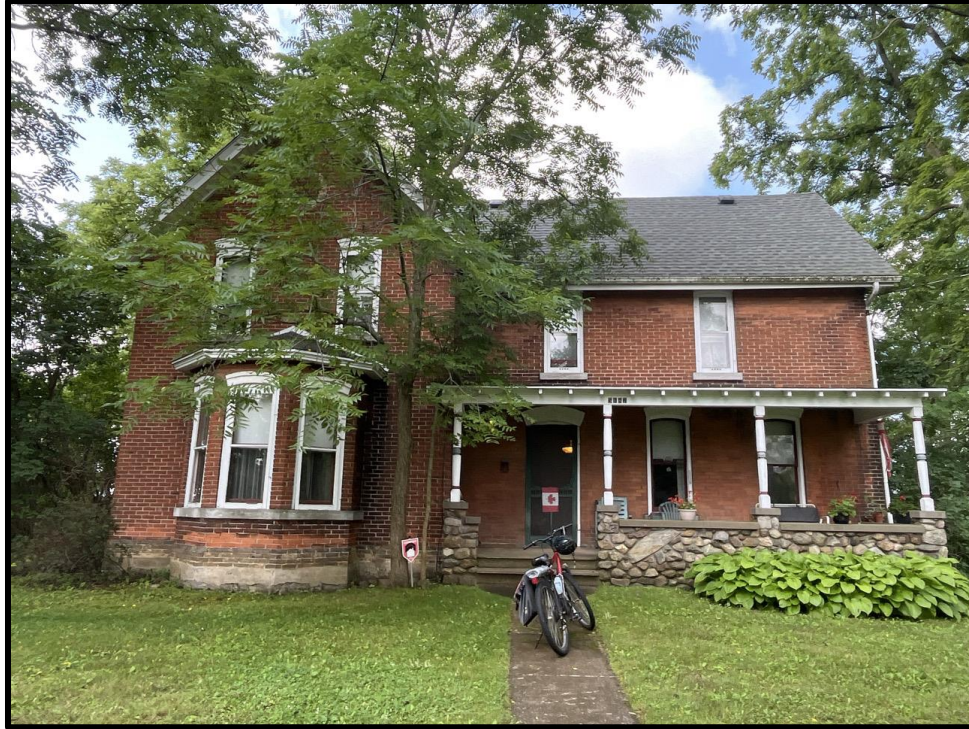
**Image 1: Façade of 5187 Sherkston Road  
(Photo taken July 21, 2023; Facing Southwest)**

**5187 Sherkston Road contains a representative example of a Gothic Revival farmhouse.** The two-storey red brick farmhouse retains much of the original historic fabric. The overall massing, roof line, fenestration, windows, and large gable end with dichromatic brickwork are reflective of a Gothic Revival farmhouse architectural style. Gothic Revival dwellings are commonly found throughout Ontario especially on rural farmsteads.

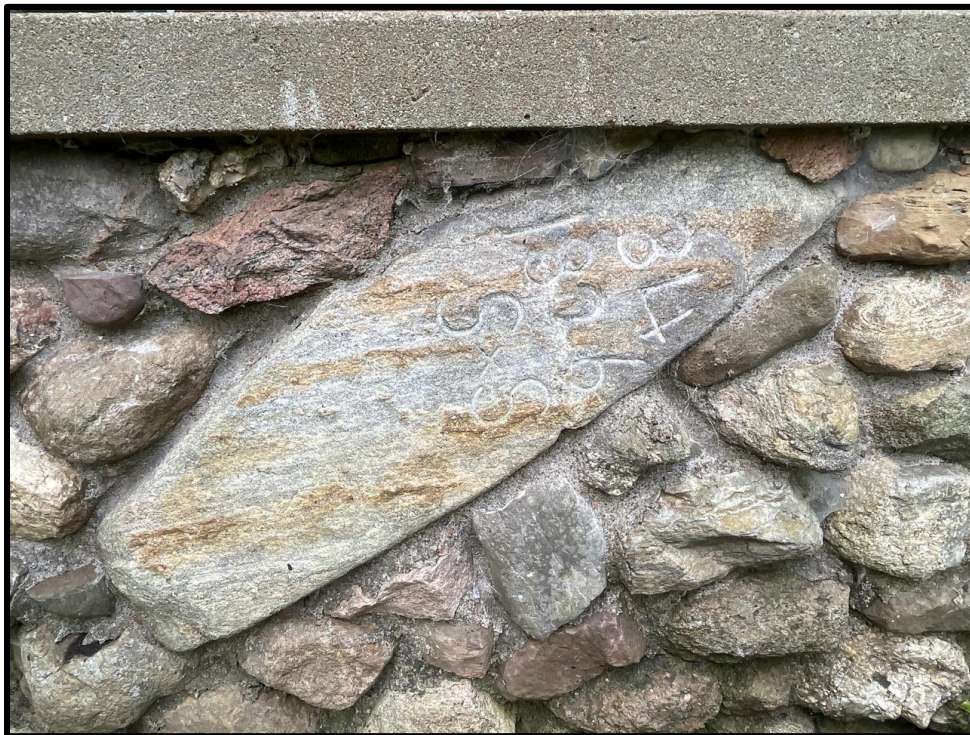
**Image 2: Detail Ordnance Stone in Front Porch Wall  
(Photo taken July 21, 2023; Facing Southwest)**

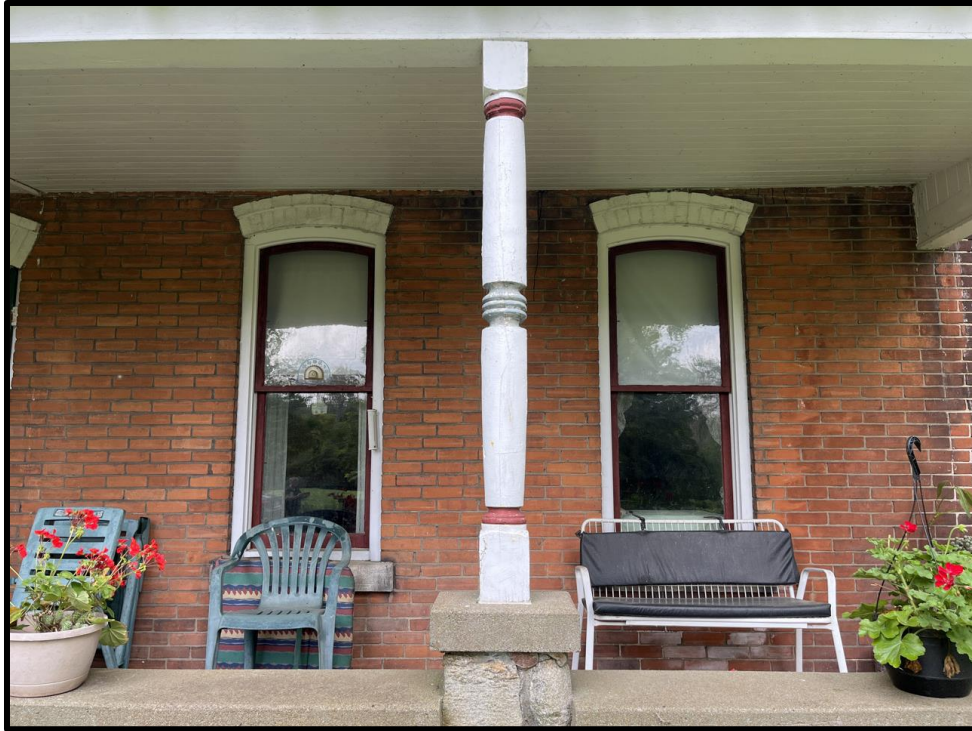
**Image 3: Detail of Window Openings on Façade of 5187 Sherkston Road  
(Photo taken on July 21, 2023; Facing Southwest)**

- Segmentally arched window and door openings are topped by a buff brick voussoir and supported by dressed stone sills (Image 10)
    - Most windows are single-paned sash with some two-paned, and four-over-four storms (Image 3, Image 5, Image 6, and Image 10)

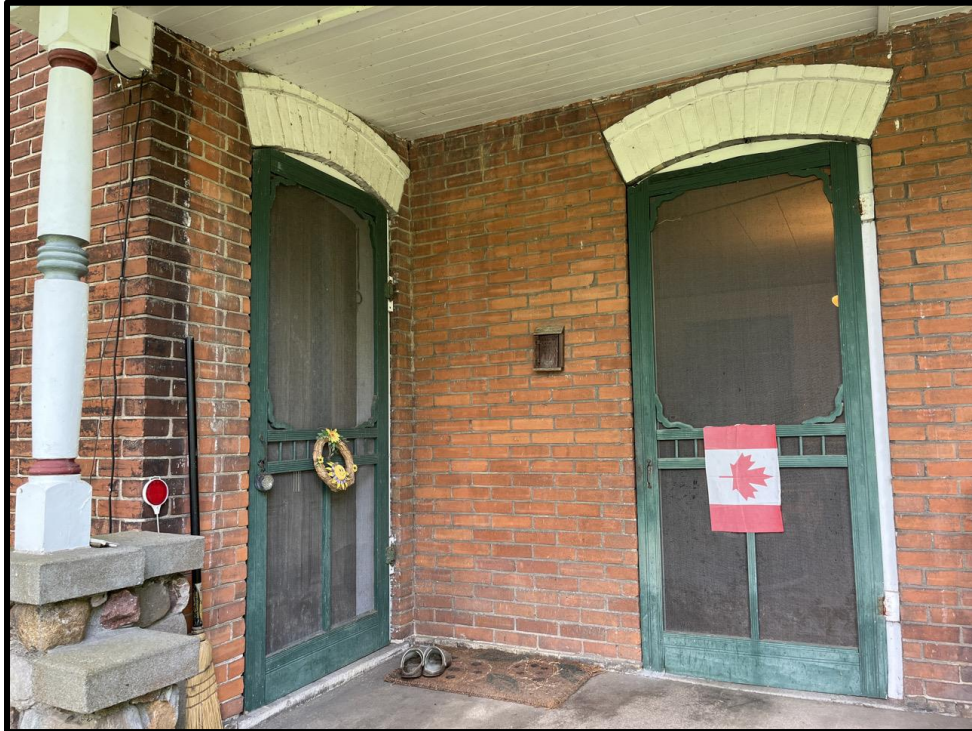
**Image 4: Entryway Detail of 5187 Sherkston Road  
(Photo taken on July 21, 2023; Facing Southwest)**

- The façade is asymmetrical however there is an overall cohesiveness in design from part to part
  - The side gable portion has three bays
  - On the first storey there are two entryways entirely sheltered by a porch (Image 1, Image 3, Image 4) and a large gable end with a projecting one-storey bay below two symmetrically placed segmentally arched windows on upper storey (Image 1, Image 5, Image 6 and Image 7)

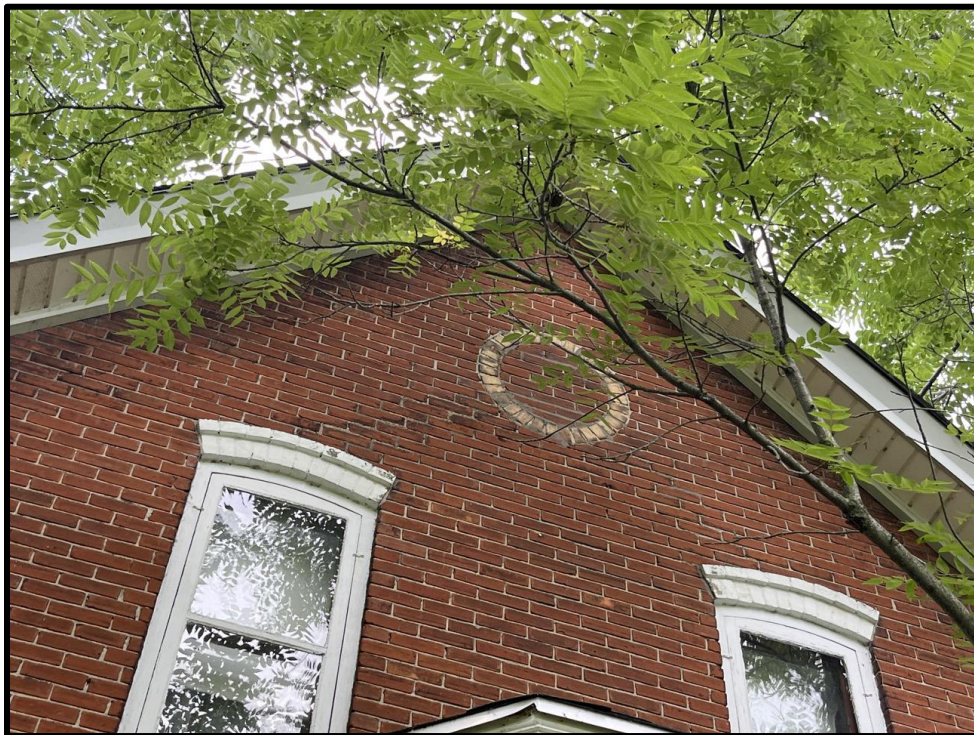
**Image 6: Detail of Buff Brick Round Feature in Façade Gable End of 5187 Sherston Road  
(Photo taken on July 21, 2023; Facing Southwest)**

- A buff brick circular brick feature is found in the gable peak
    - The porch is shed roof-covered supported by split posts on a stone base

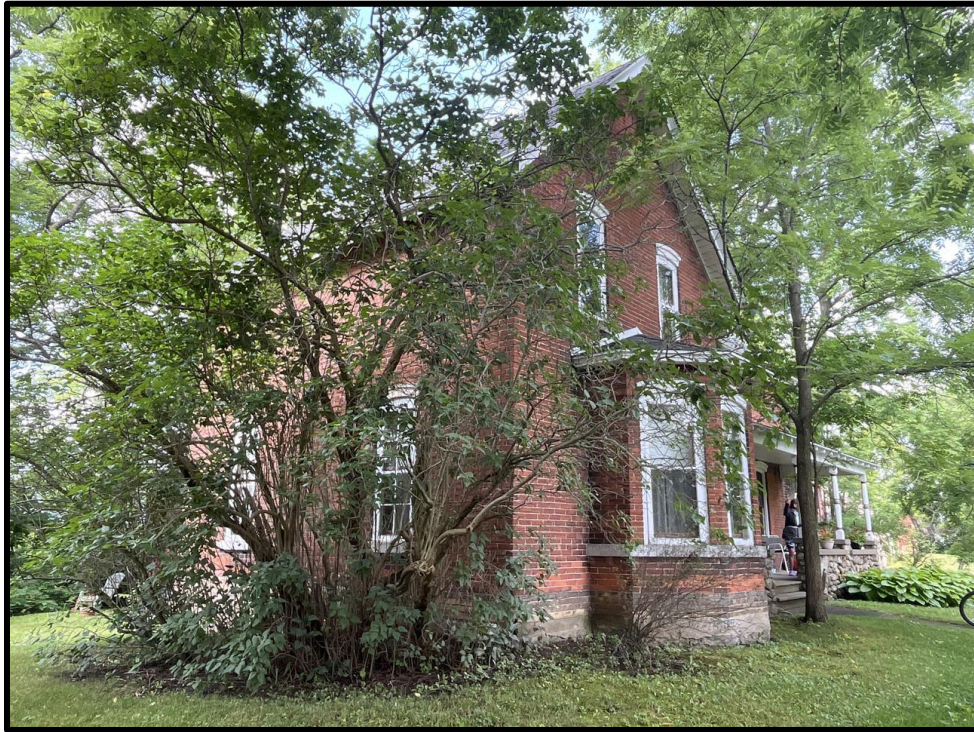
**Image 7: East Corner of 5187 Sherkston Road  
(Photo taken on July 21, 2023; Facing West)**

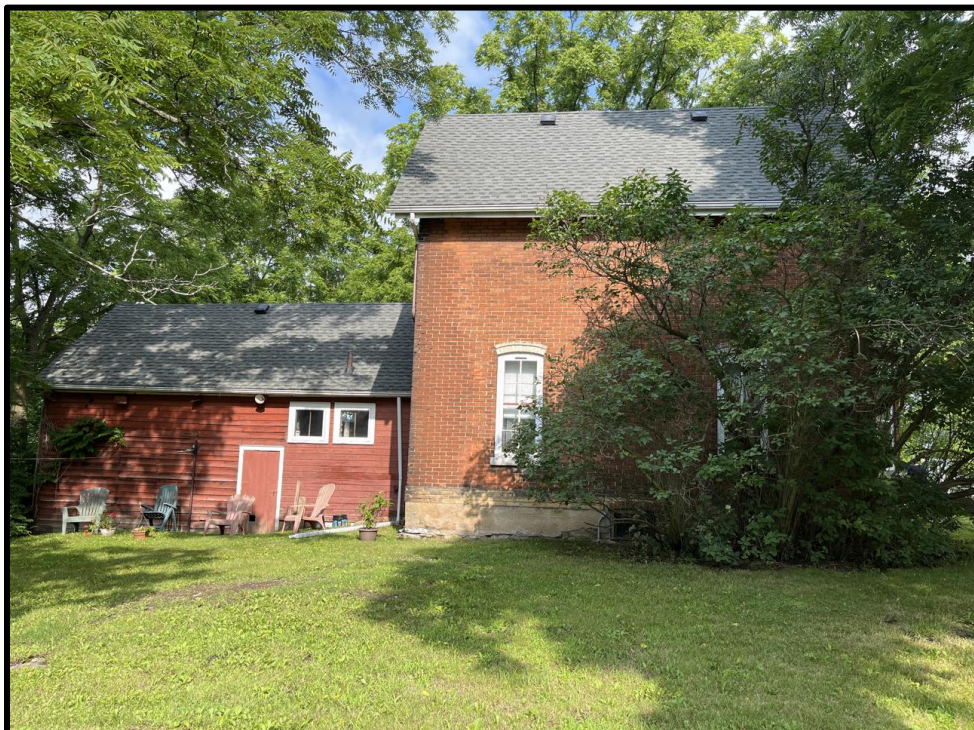
**Image 8: Southeast Elevation of 5187 Sherkston Road  
(Photo taken on July 21, 2023; Facing Northwest)**

- The side gable’s rear elevation is mostly obscured by the addition; however, one segmentally arched window is visible (Image 8, Image 9, Image 13-Image 18)

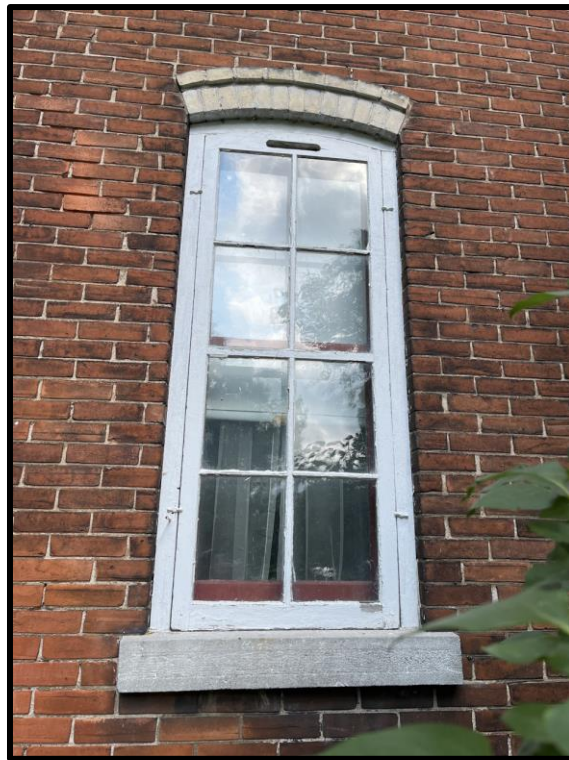
**Image 10: Detail of Window with Buff Brick Voussoirs and Dressed Stone Sill of 5187  
Sherkston Road  
(Photo taken on July 21, 2023; Facing Northwest)**

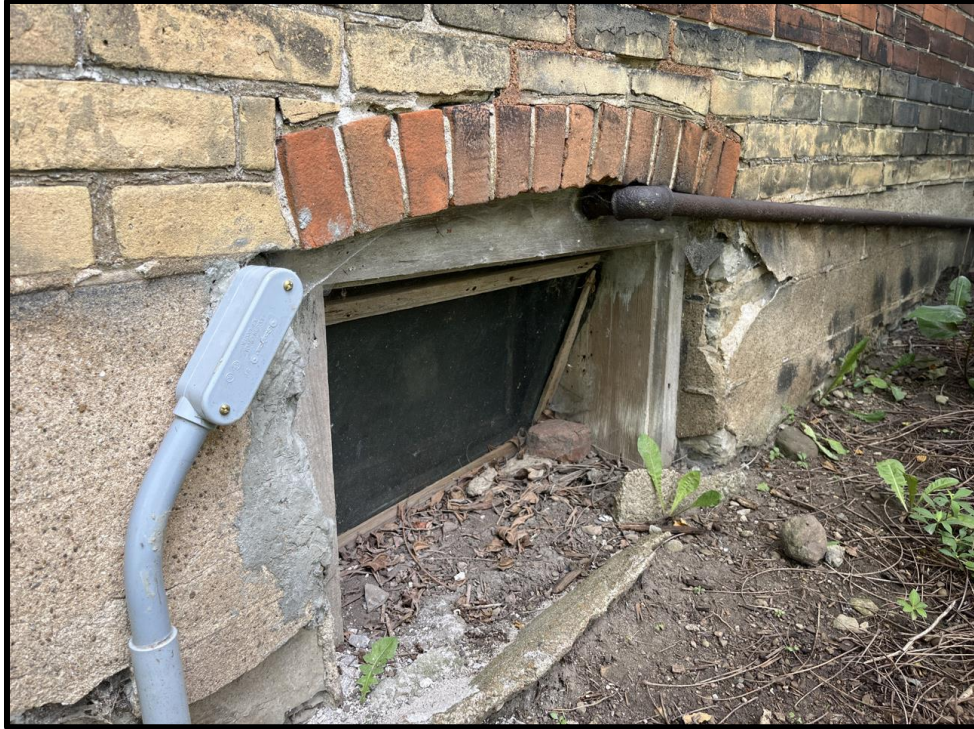
- Basement window openings are rectangular with red brick voussoirs (Image 10)
  - The foundation has been parged, though some dressed stone foundation is visible beneath the parging (see Image 11, Image 12)

**Image 11: Detail of Basement Window and Foundation of 5187 Sherkeston Road**  
(Photo taken on July 21, 2023; Facing Northwest)

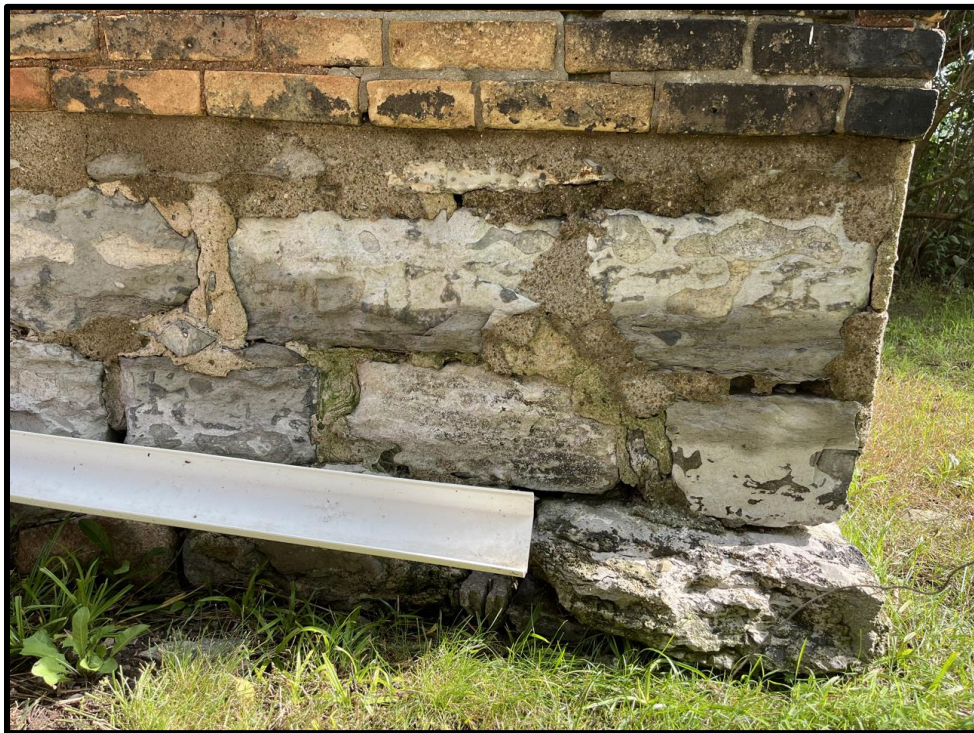
**Image 12: Detail of Foundation at South Corner of 5187 Sherkeston Road**  
(Photo taken on July 21, 2023; Facing West)

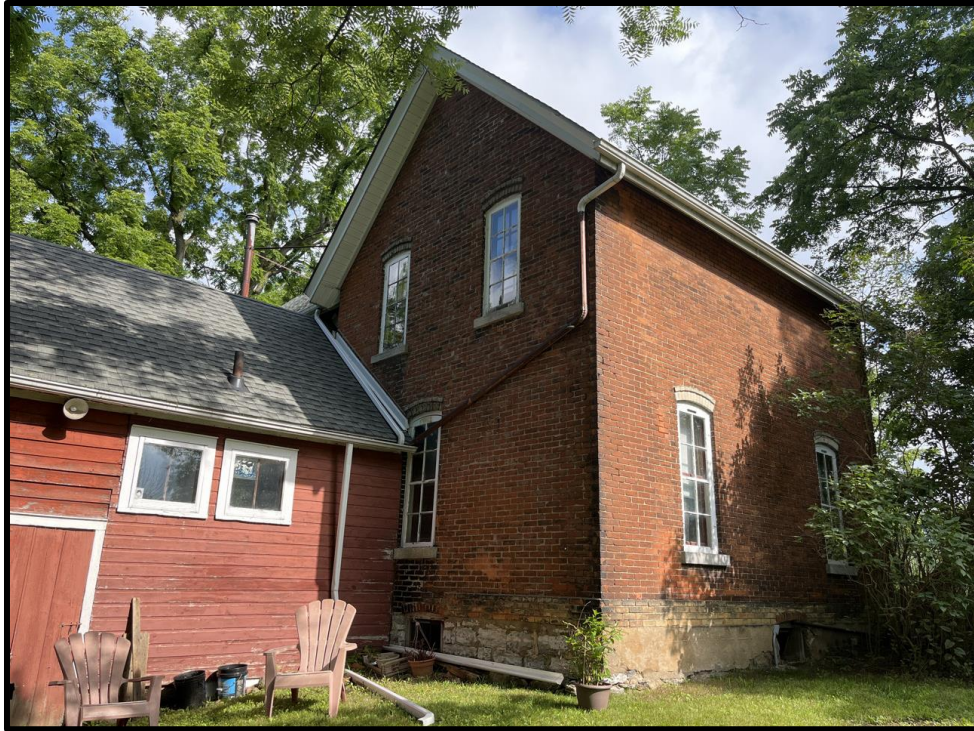
**Image 13: South Corner of 5187 Sherston Road  
(Photo taken on July 21, 2023; Facing North)**

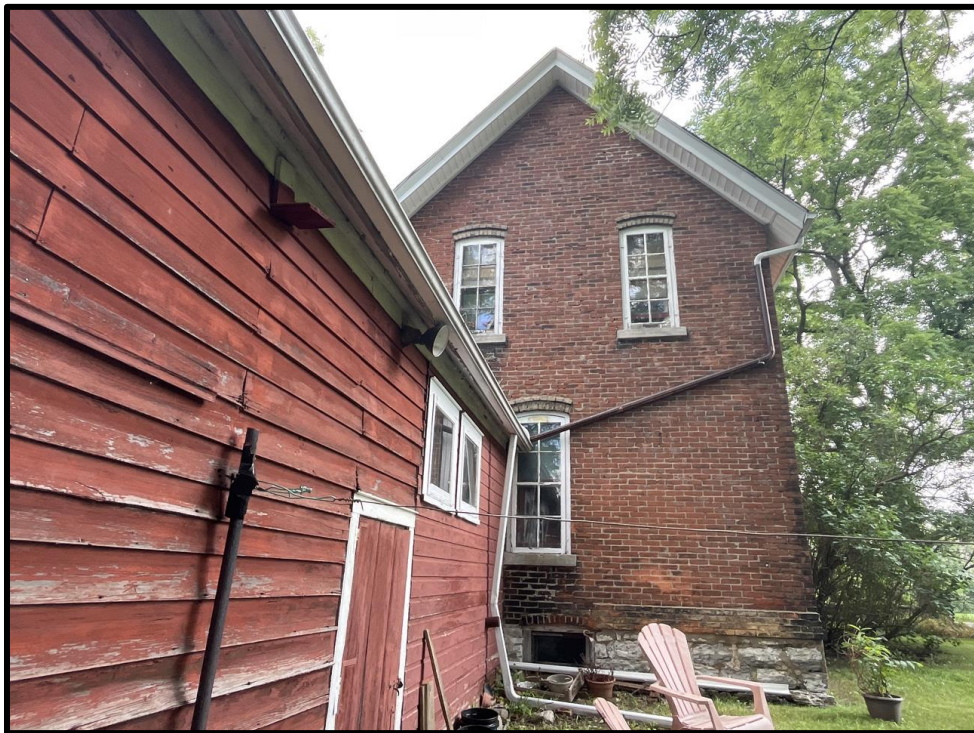
**Image 14: Main House - Southwest Elevation of 5187 Sherston Road  
(Photo taken on July 21, 2023; Facing Northeast)**

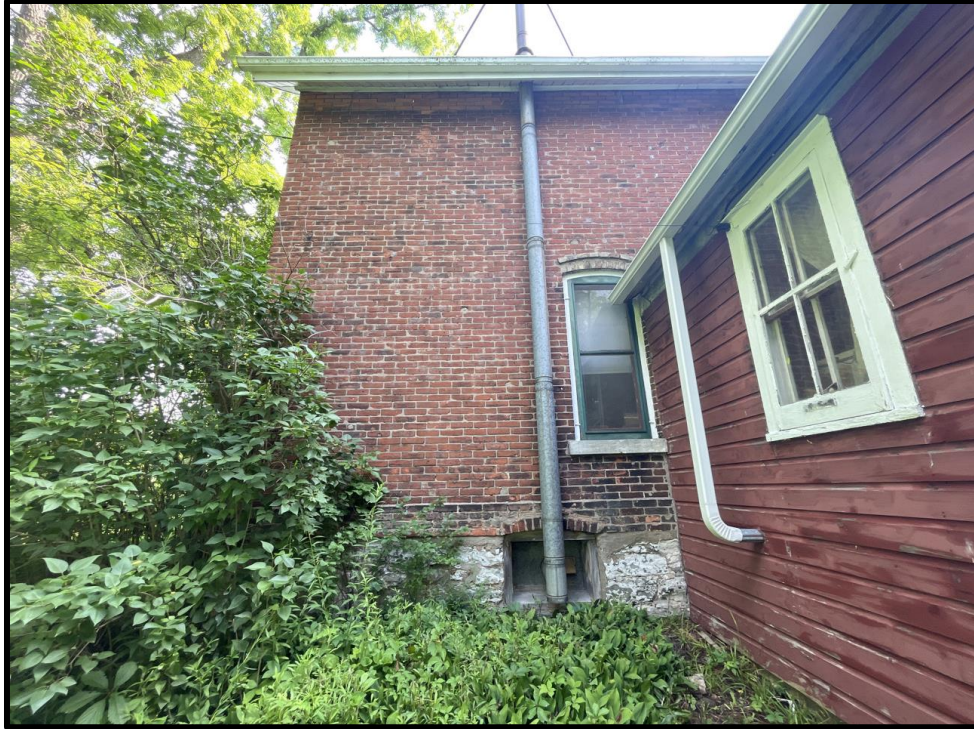
**Image 15: Main House - Southwest Elevation of 5187 Sherkston Road  
(Photo taken on July 21, 2023; Facing Northeast)**

- The frame addition is accessed by a door on each elevation and is lighted by square and rectangular window openings (Image 15). It has a gable roof and is made with clapboard (in part) and cove siding (in part)

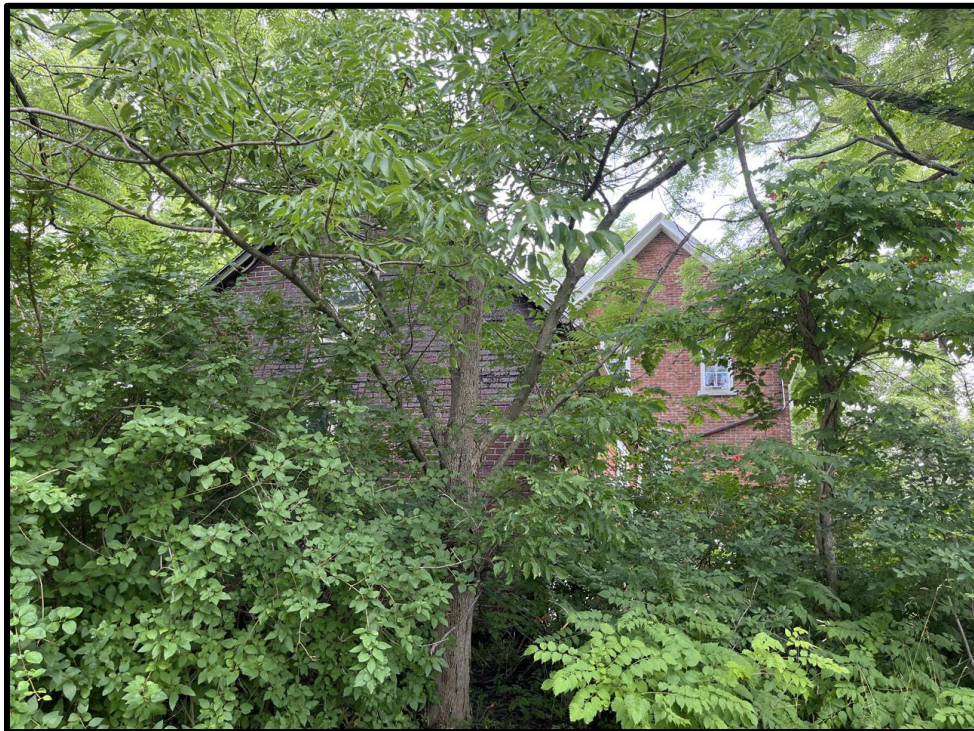
**Image 16: Addition - Southwest Elevation of 5187 Sherkston Road  
(Photo taken on July 21, 2023; Facing Northeast)**

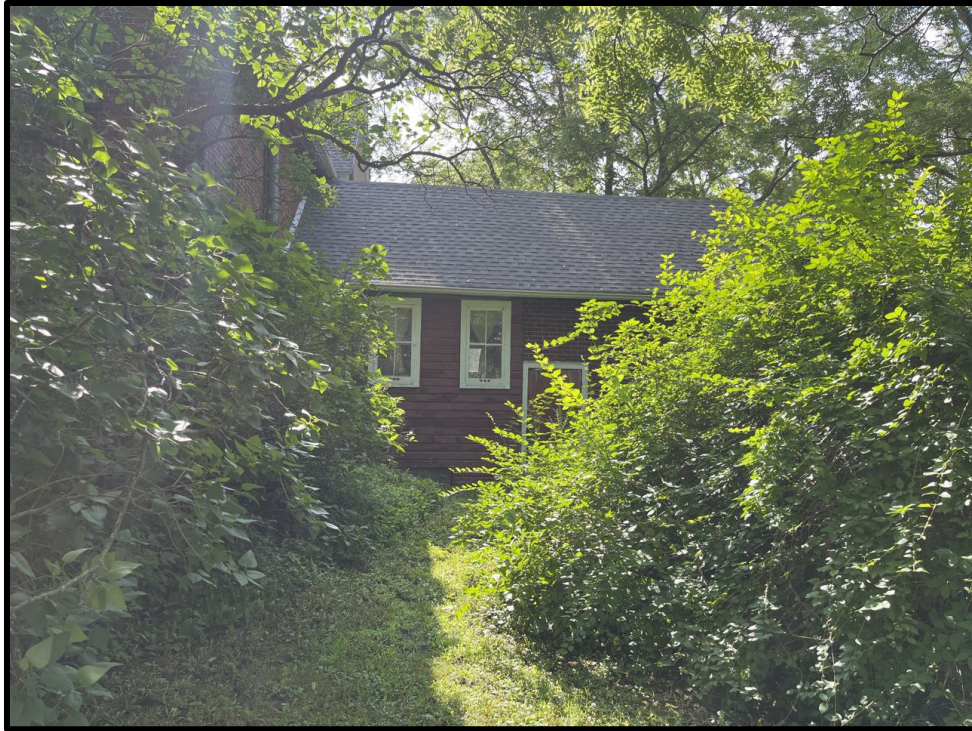
**Image 17: Addition - Northwest Elevation of 5187 Sherkston Road  
(Photo taken on July 21, 2023; Facing Northeast)**

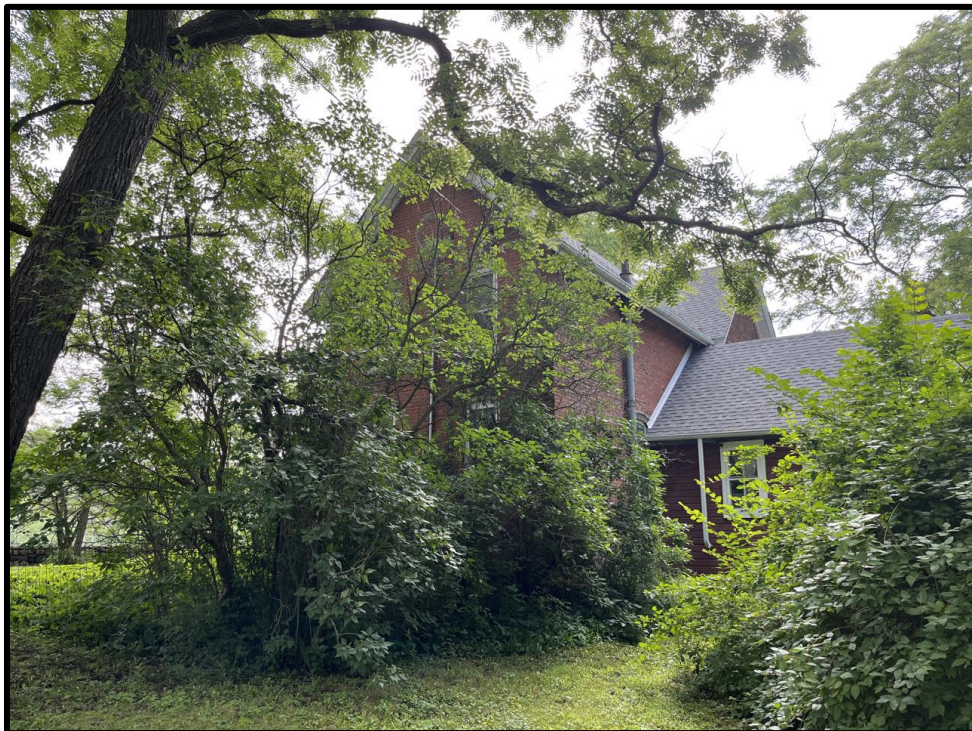
**Image 18: West Corner of 5187 Sherkston Road  
(Photo taken on July 21, 2023; Facing East)**

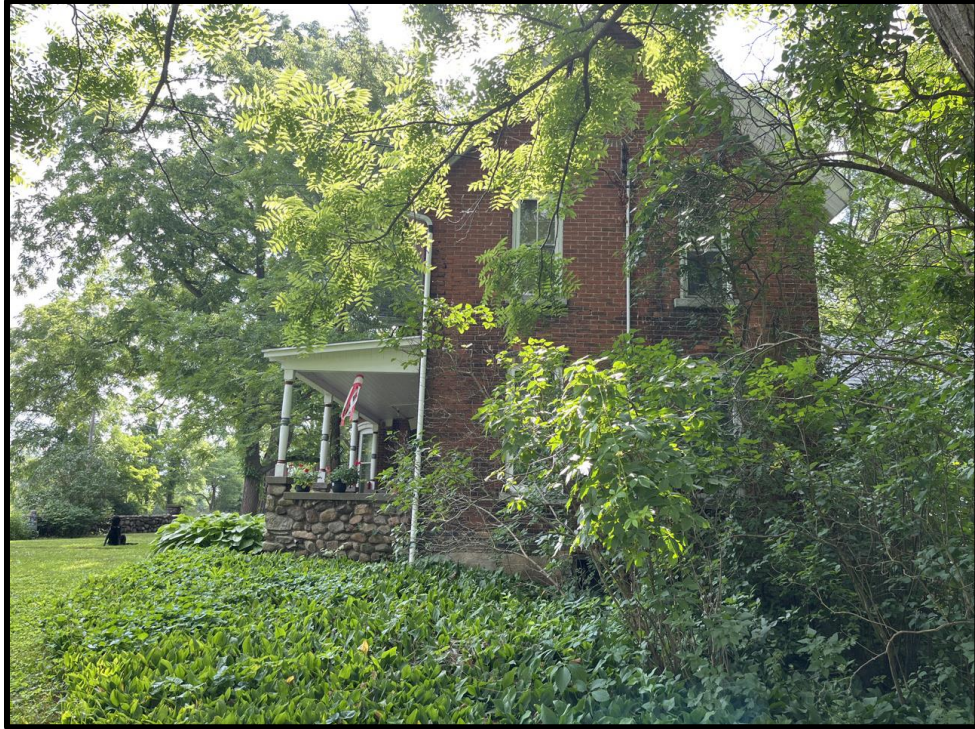
**Image 19: Main House - Northwest Elevation of 5187 Sherston Road  
(Photo taken on July 21, 2023; Facing Southeast)**

- Northwest elevation is two-bay with segmentally arched windows on both storeys
  - The buff-brick circle detail is featured in this gable end as well (Image 19-Image 21)

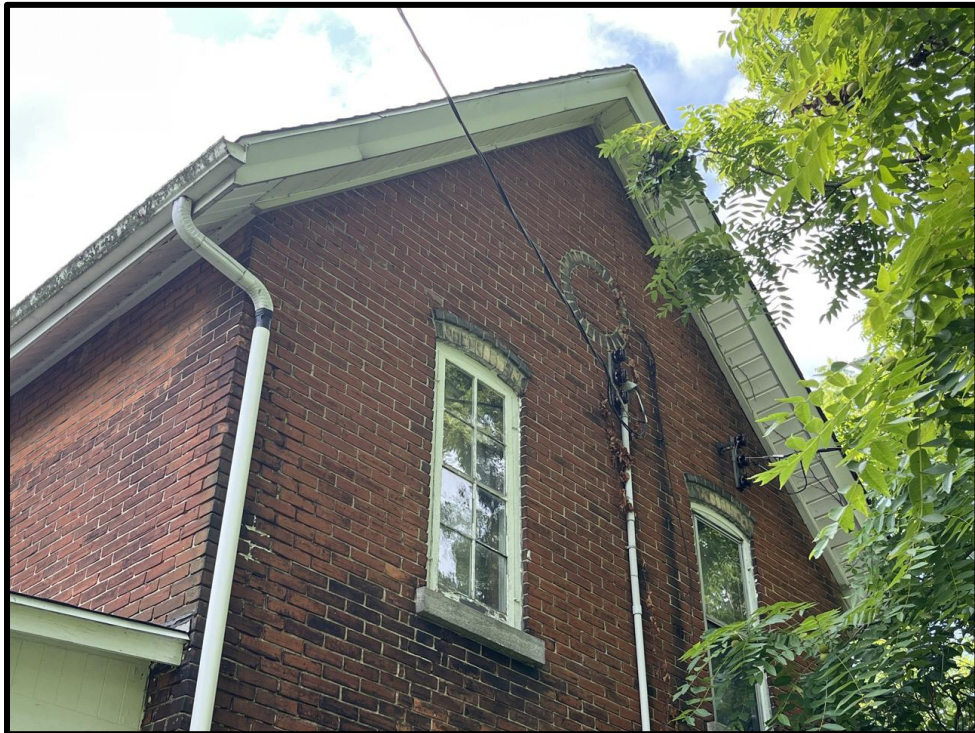
**Image 20: Detail of Buff Brick Round Feature in Northwest Elevation Gable End of 5187  
Sherston Road  
(Photo taken on July 21, 2023; Facing Southeast)**

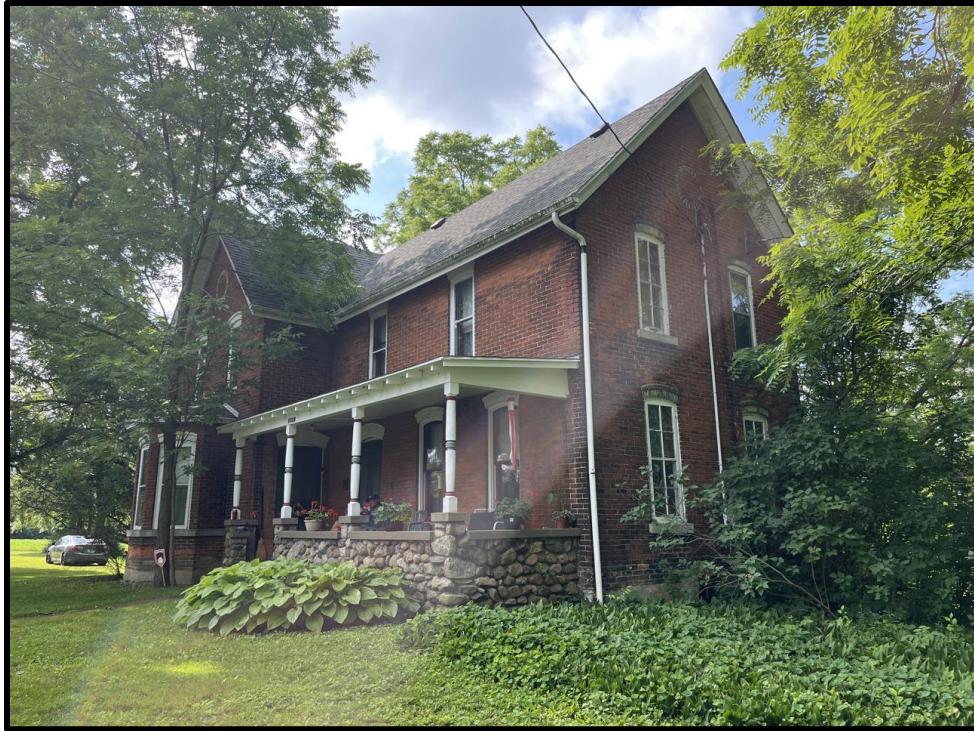
**Image 21: North Corner of 5187 Sherkston Road  
(Photo taken on July 21, 2023; Facing South)**

- Two-storey frame brick-clad building follows a L-shaped plan (Image 1)
  - Front gable roof with a side gable on the northwest (side) elevation and one-storey addition on the rear (Image 1, Image 9, Image 21)

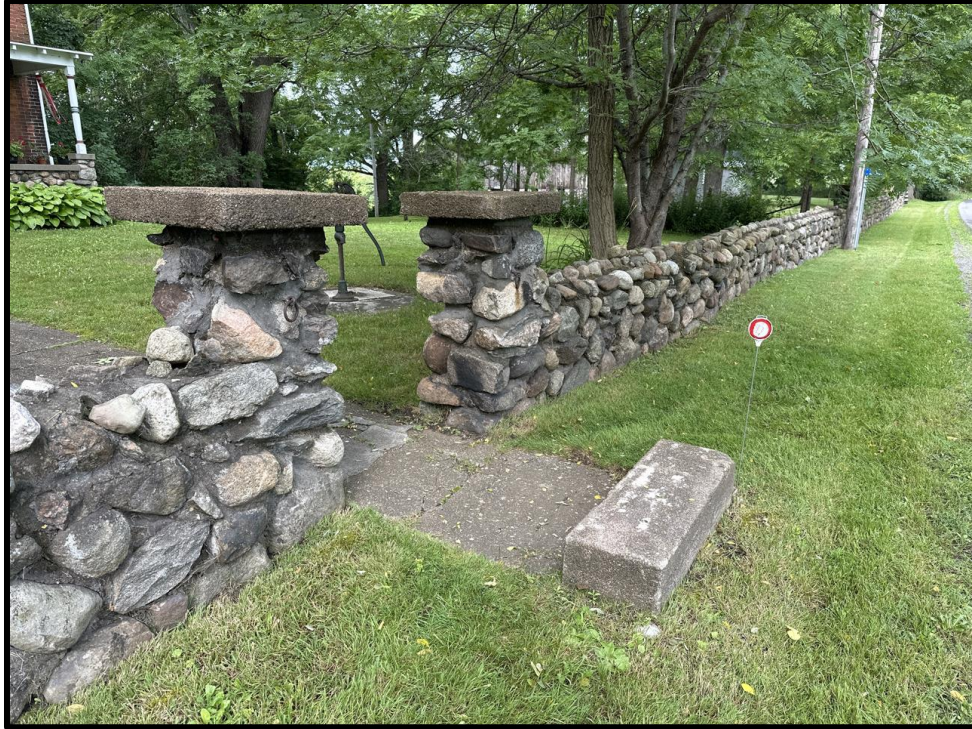
**Image 23: Landscape Feature – Stone Wall, Buggy Step and Hitching Posts**  
(Photo taken on July 21, 2023; Facing Northwest)

- Stones used for base of porch share a similar appearance to the stone wall
  - It is possible that this porch was added and/or updated at the time the stone wall was constructed in 1916 (A. Herlovitch. Pers. Communication), however, no corroborating evidence was found to confirm this.

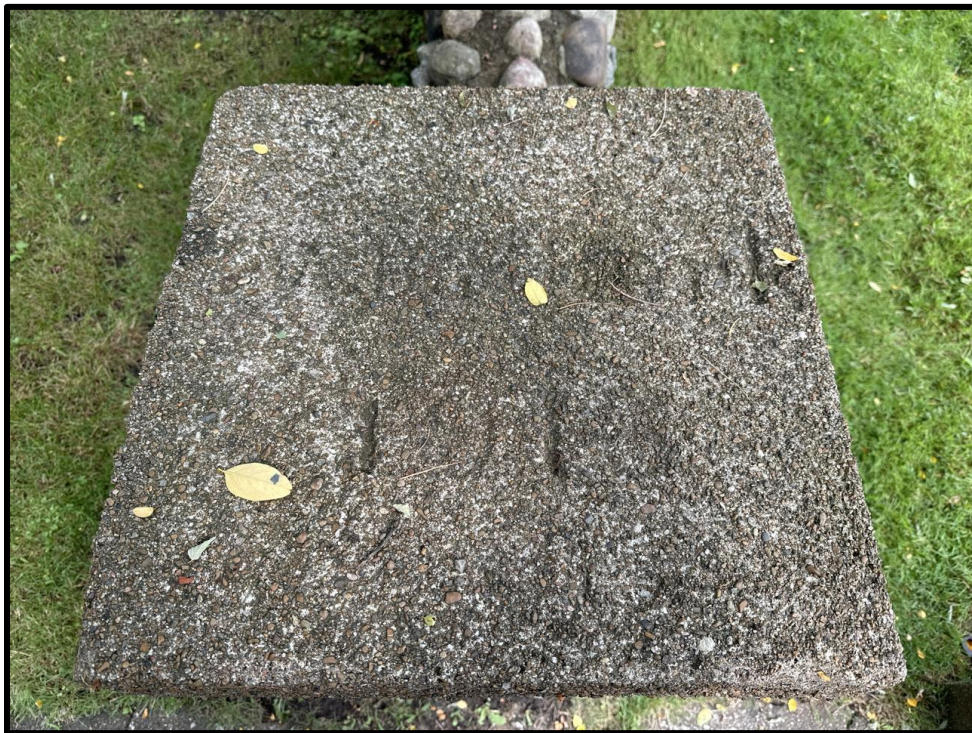
**Image 24: Landscape Feature – Gatepost with Inscription “M.B. Sherk 1916”**  
(Photo taken on July 21, 2023; Facing Northwest)

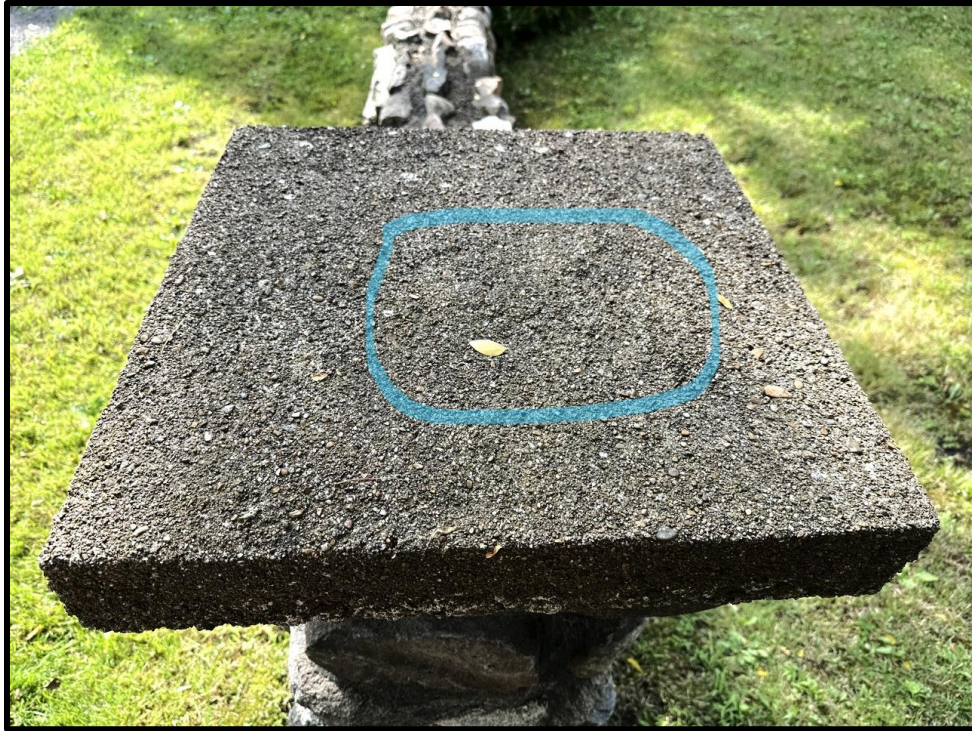
**Image 25: Landscape Feature – Gatepost with Baby Footprints of MB Sherk’s daughter**  
(Photo taken on July 21, 2023; Facing Southeast)

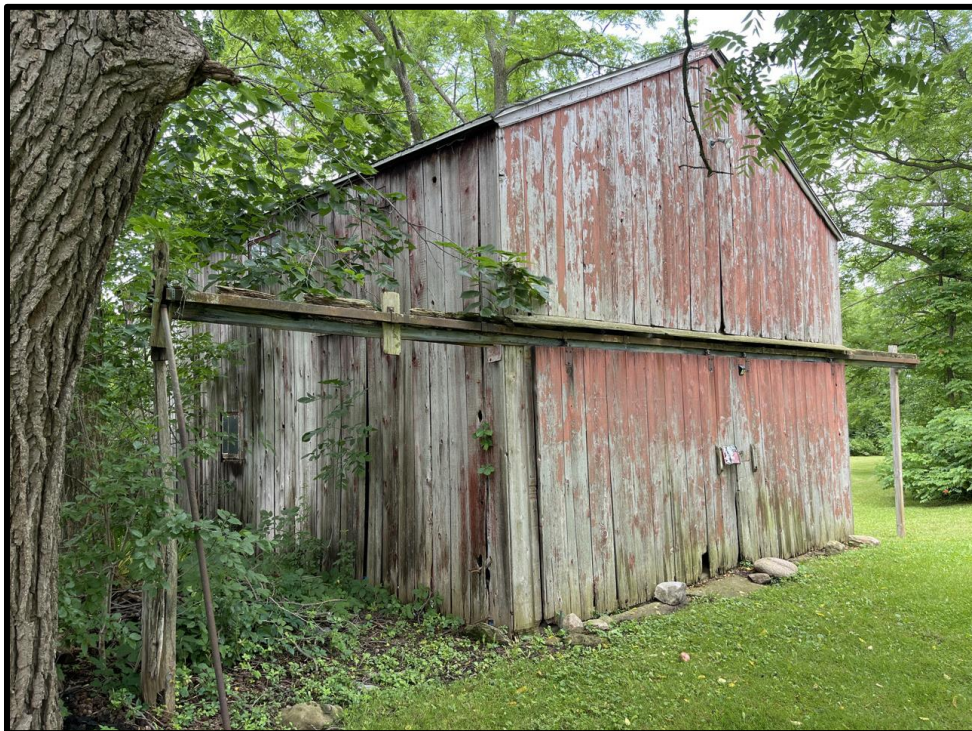
**Image 26: Outbuilding – Drive Shed**  
(Photo taken on July 21, 2023; Facing West)

- Drive shed behind main building with a front gable roof, a large sliding door entryway in the gable end facing Sherkston Road and limited window openings, clad with vertical barnboard (Image 26)

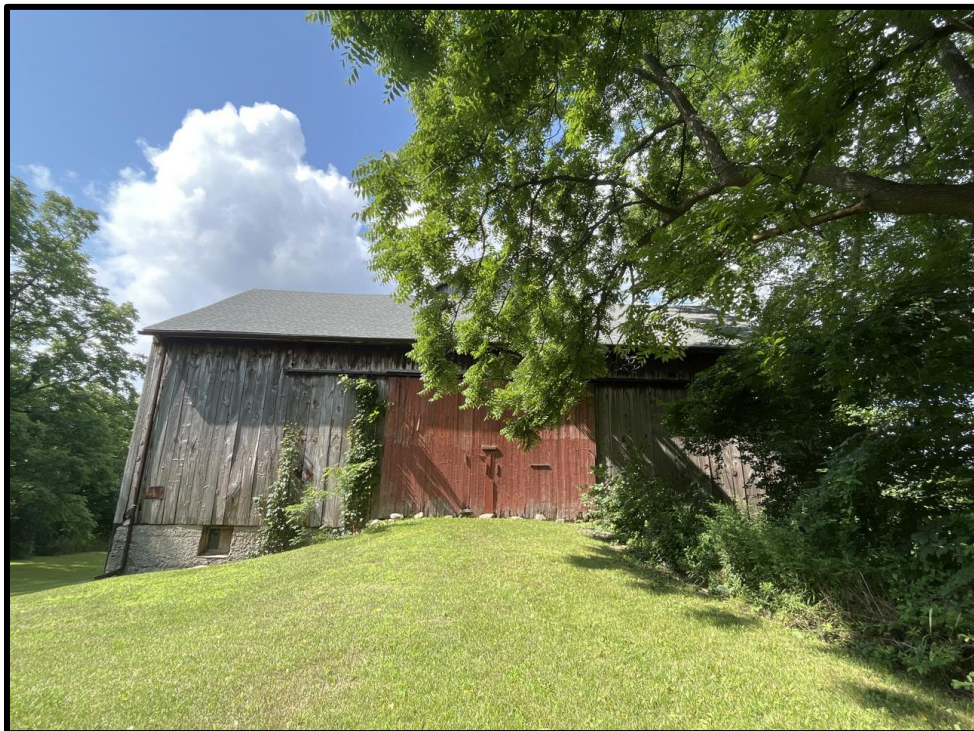
**Image 28: Outbuilding – Barn Northwest Elevation**  
(Photo taken on July 21, 2023; Facing Southwest)

**5187 Sherkston Road contains a representative example of a Central Ontario Barn (also known as a "bank barn").** The large two storey wooden structure is built on stone foundation set into a slope, with a gable roof, large side doors, and wood frame construction all representative features of this barn typology.

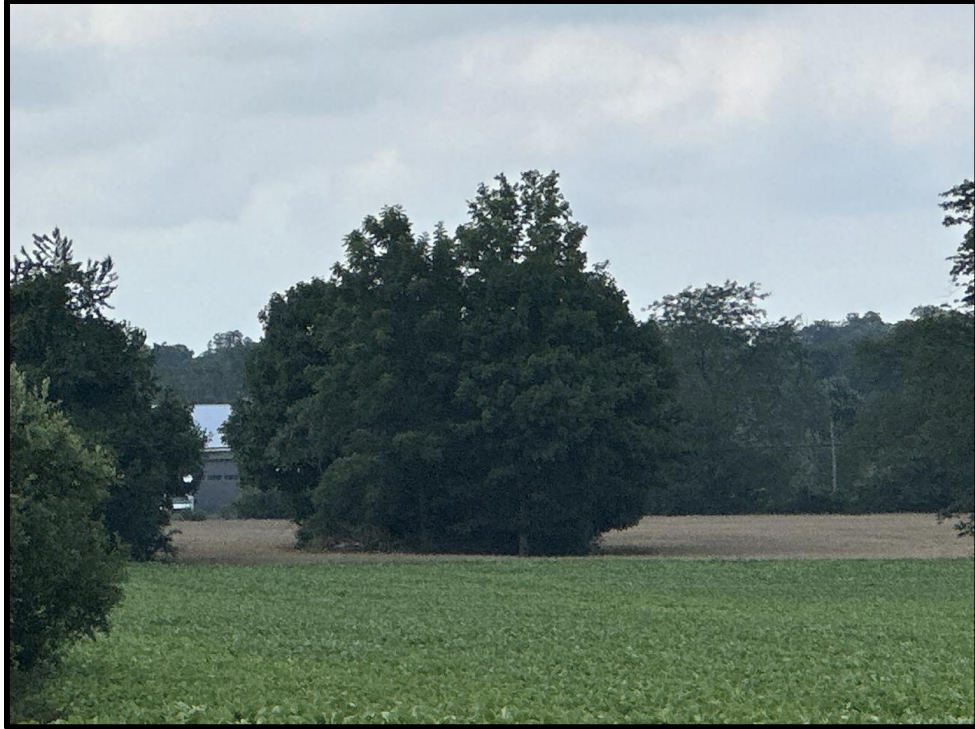
**Image 37: Landscape – Detail – Lime Kiln Remnants, South of Barn/House  
(Photo taken on July 21, 2023; Facing South)**
