## Planning and Development Services

Report: PDS-22-2024

Heritage Property Designation – 5187 Sherkston Road

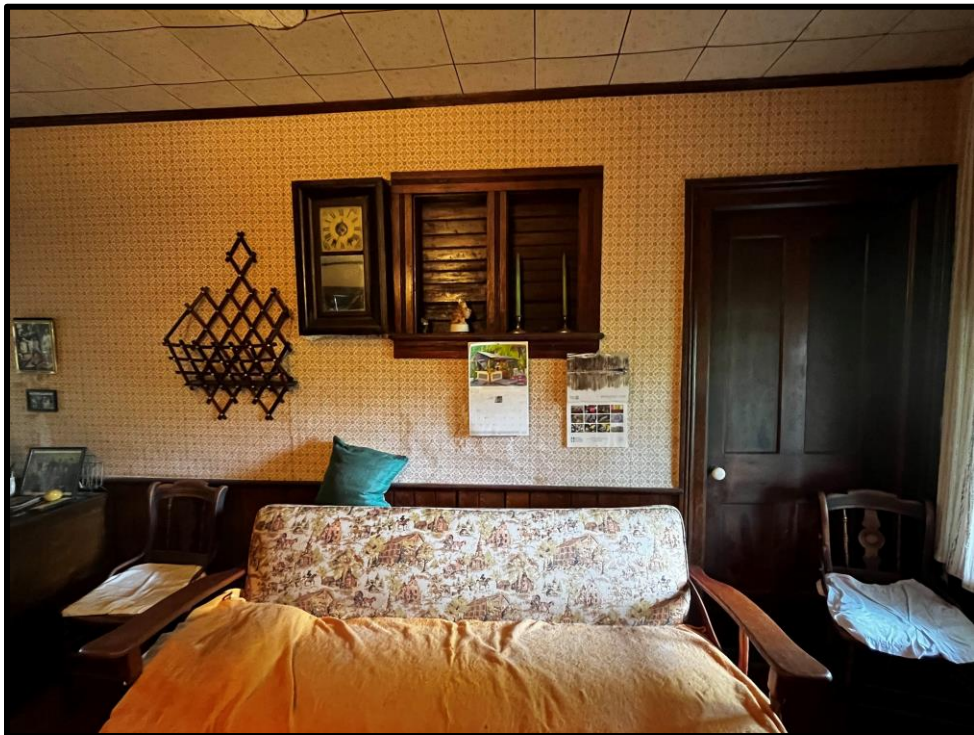
**Image 47: Interior – First Floor Family Room – Detail of Built-in Wood Cabinetry  
(Photo taken on July 21, 2023)**

The interior finishes of the residence appear to be relatively unchanged. Access was granted to the front room, kitchen and basement (Image 47–Image 54).

- The original 19<sup>th</sup> century interior layout of the farmhouse appears to remain intact
- The main floor consists of a family room leading to a small kitchenette to the east, and closed doorways leading south and west. (Image 47–Image 50).

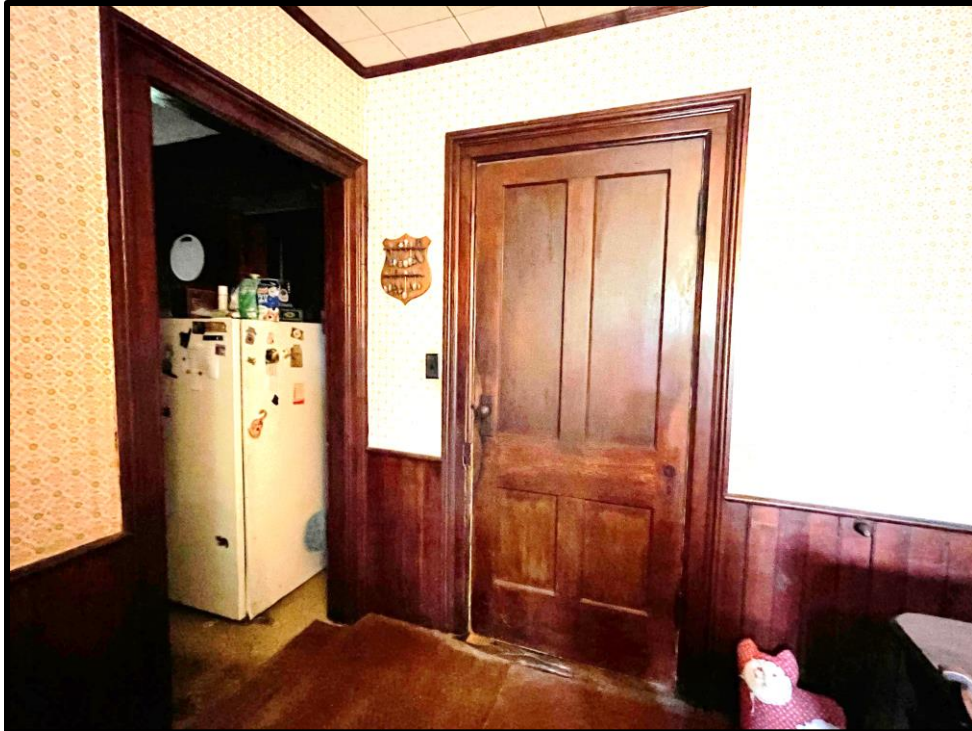
**Image 48: Interior – First Floor Family Room – Detail of Built-in Wood Cabinetry  
(Photo taken on July 21, 2023)**

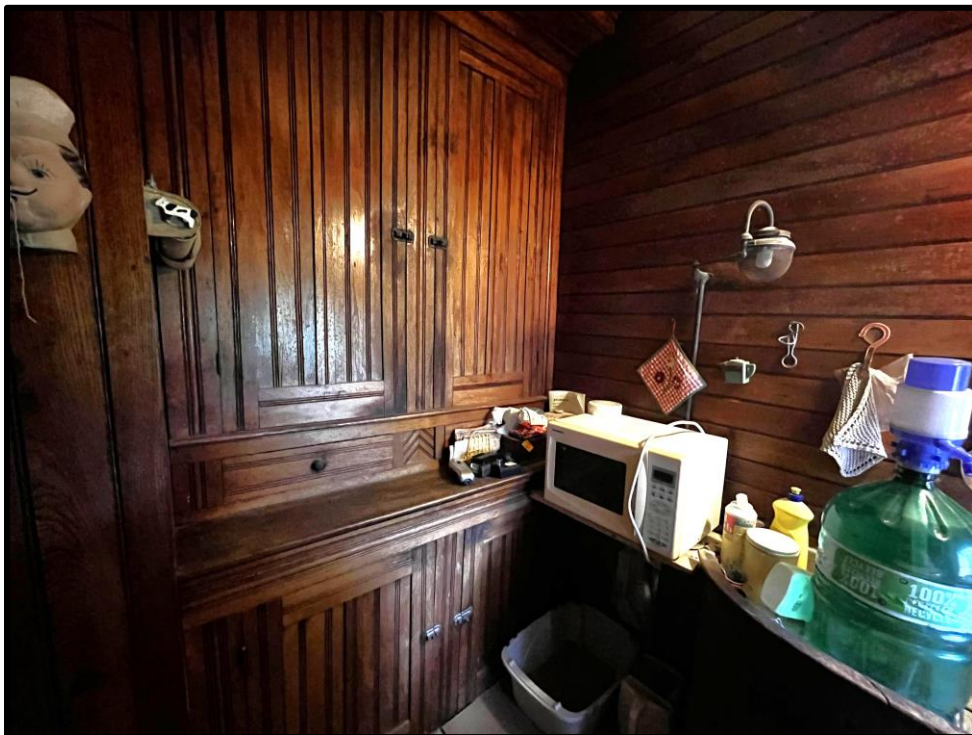
**Image 49: Interior – First Floor Family Room – Detail of Interior Door and Wood Surround**  
(Photo taken on July 21, 2023)

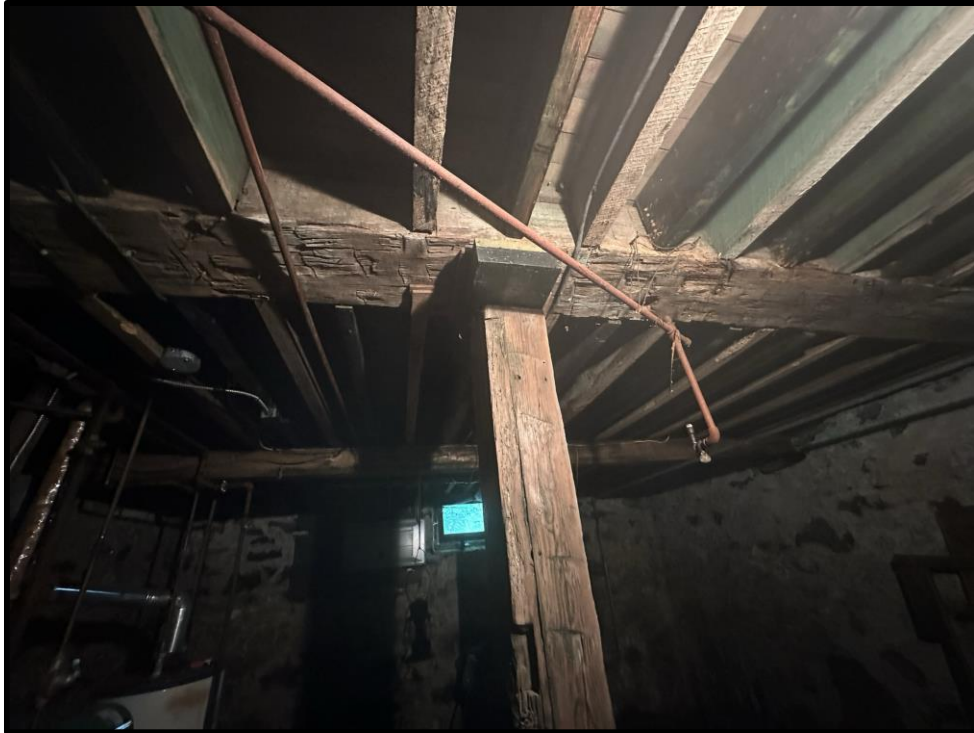
- The original wood floorboards remain in the family room.
- The basement is unfinished with concrete floor with access from the house via a staircase.
- Hand-hewn log beams and pillars support the foundations throughout the basement of the dwelling together with poured-in-place concrete walls.

**Image 51: Interior Detail of Hand-hewn Log Beams – 5187 Sherkston Road  
(Photo taken on July 21, 2023)**

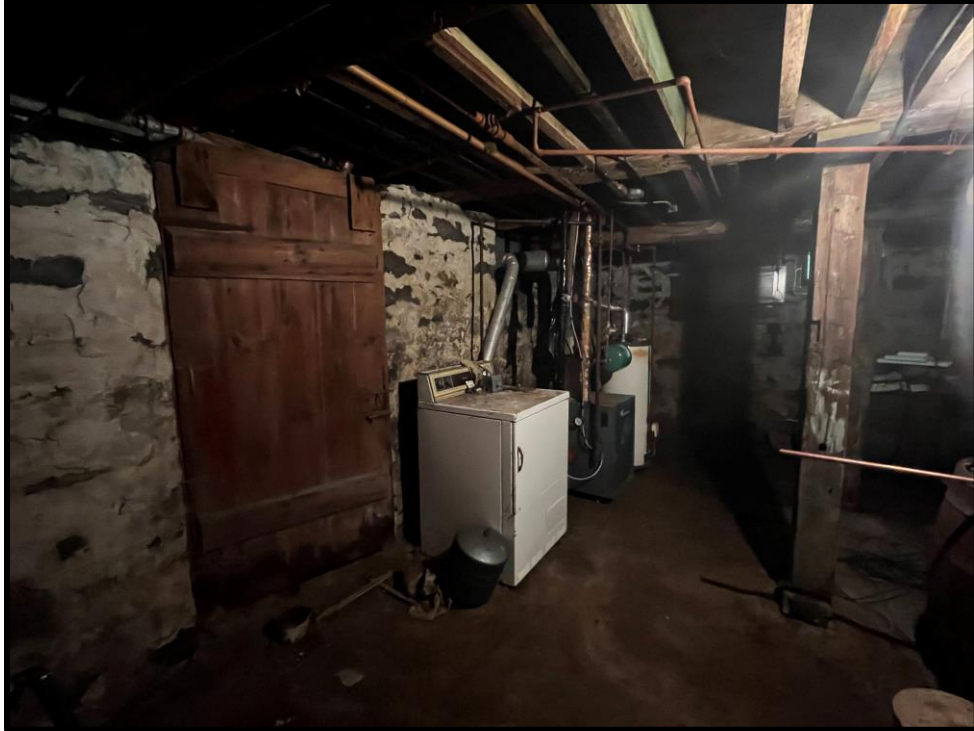
**Image 53: Interior – Basement - Detail of Poured Stone Foundation Walls – 5187 Sherkston Road**  
(Photo taken on July 21, 2023)

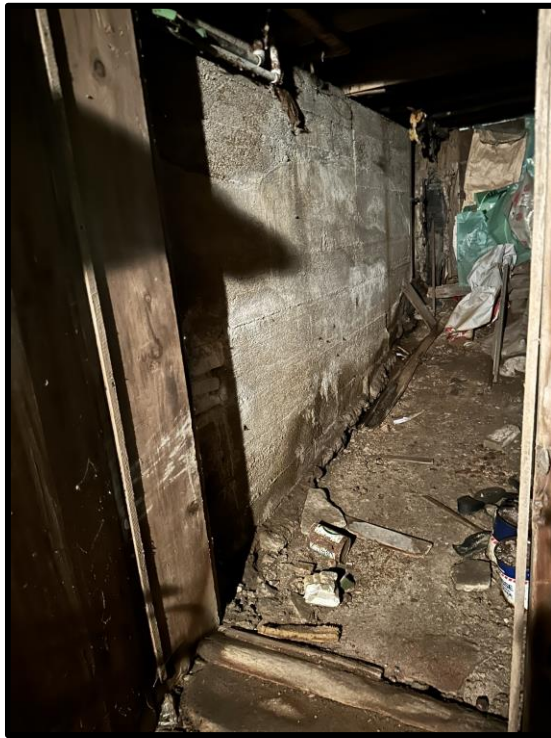
**Image 54: Interior – Basement - Detail of Poured in Place Concrete Walls – 5187 Sherkston Road**  
(Photo taken on July 21, 2023)

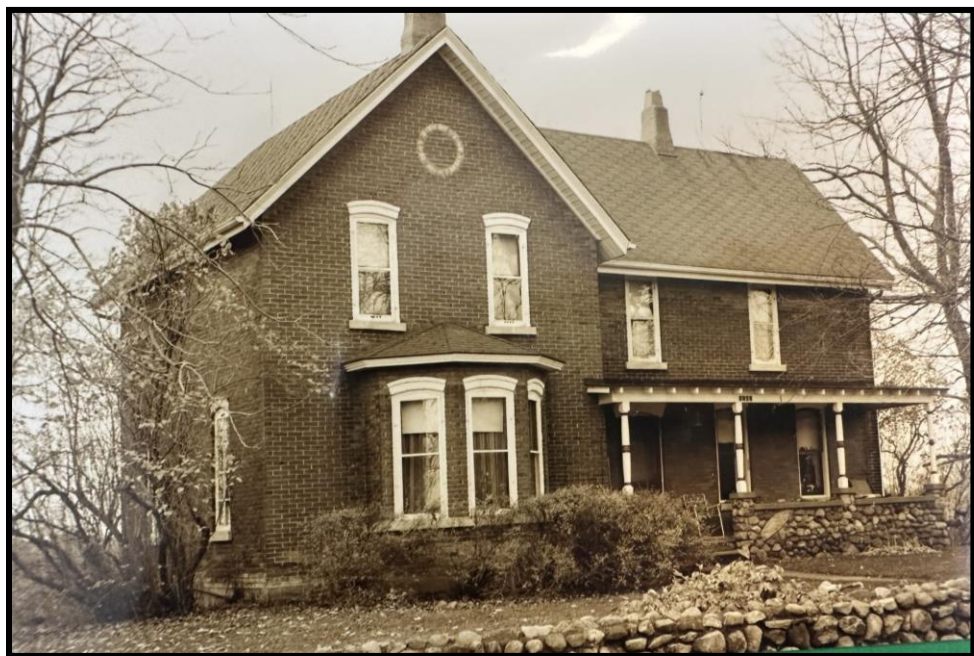
**Figure 6: Undated Photo of 5187 Sherkston Road  
(FEHM 2023a)**

- Two undated historical photographs of 5187 Sherkston Road, see Figure 6 and Figure 7.
